Bioengineering as a Tool for Restoring Ecological Integrity to the Carson River

*by Kevin L. Piper, J. Chris Hoag, Hollis H. Allen,
Gail Durham, J. Craig Fischenich, and Robert O. Anderson*

PURPOSE: This technical note describes a case study involving the following: (a) use of bioengineering (a combination of vegetation and engineered structures and materials) and rock structures to restore an eroded bank of the Carson River, Nevada, and (b) restoration of ecological amenities that existed prior to disturbances by man and a major flood event.

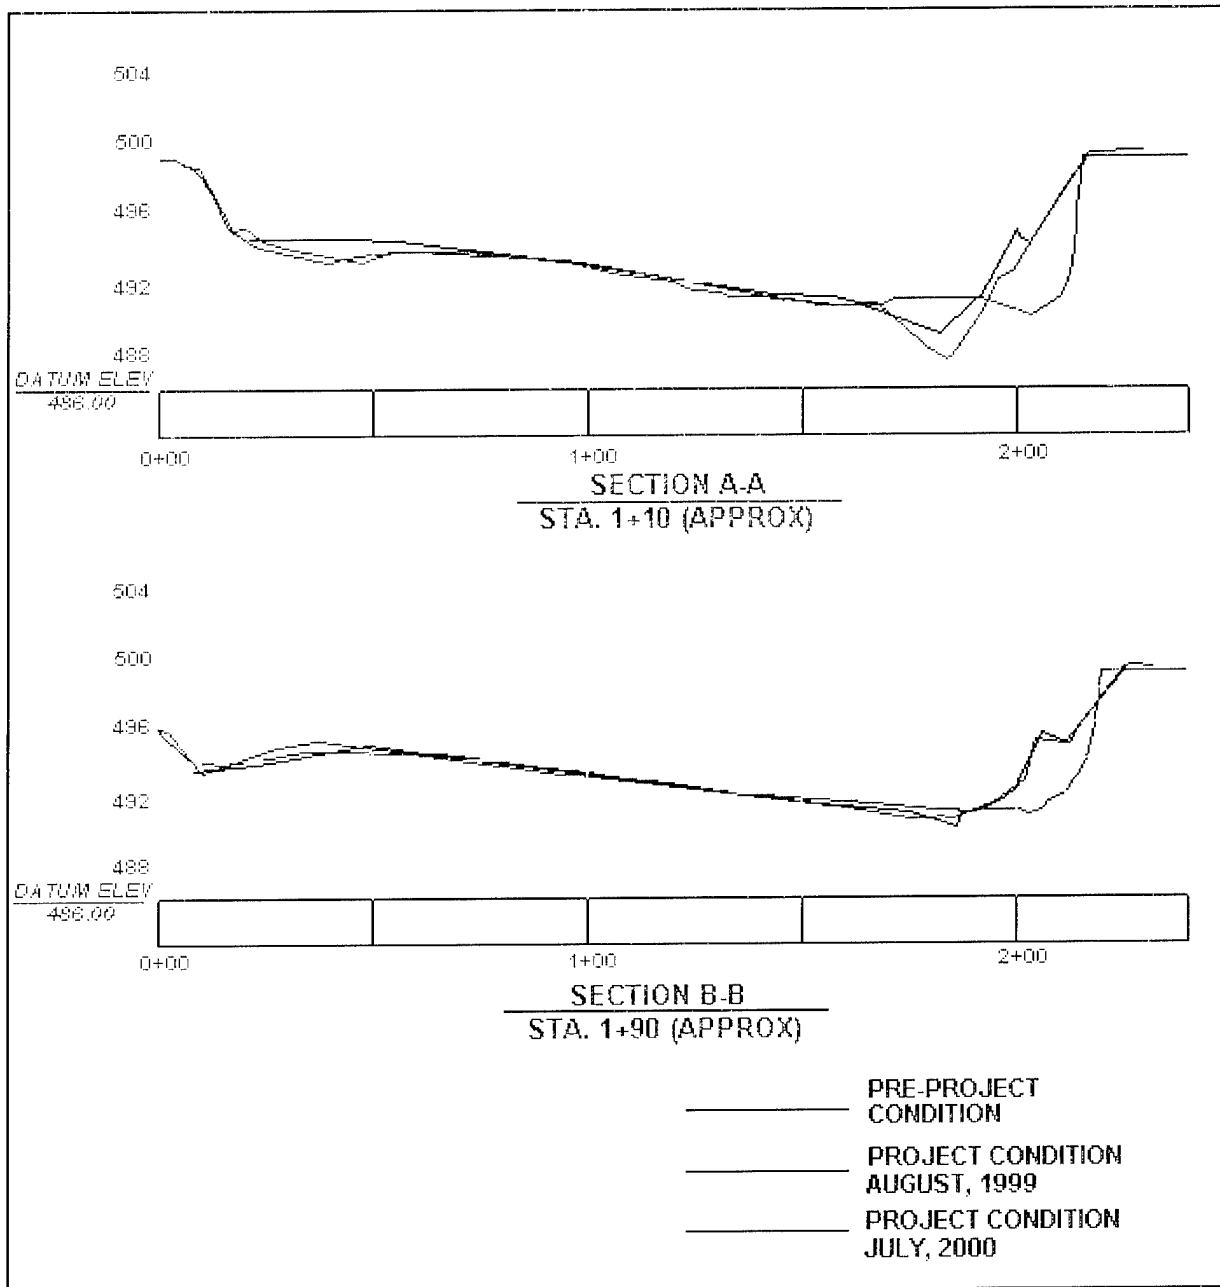
Channel morphology. The cross-sectional survey information taken between 1998 and 2000 illustrates that with one exception, the thalweg moved away from the bendway bank and that sediment accumulated between the barbs as designed (Figures A1 to A3, Appendix A). There has been 1 ft of scour in the thalweg at the most downstream station (1 + 10) and there is some evidence that scour and the change in depth of the thalweg have removed a portion of the sediment that accumulated during the prior year. At this same station, the right bank has changed in contour. The gravel bar associated with the right bank has lost material as expected and now approximates pre-project conditions. The remaining cross sections appear to be relatively stable, with only insignificant changes to the channel morphology.

Figure A-1. A-A and B-B cross sections as though looking upstream. Note how thalweg has shifted to the left and sediment has accumulated on the right bank, the eroded bank of the bendway

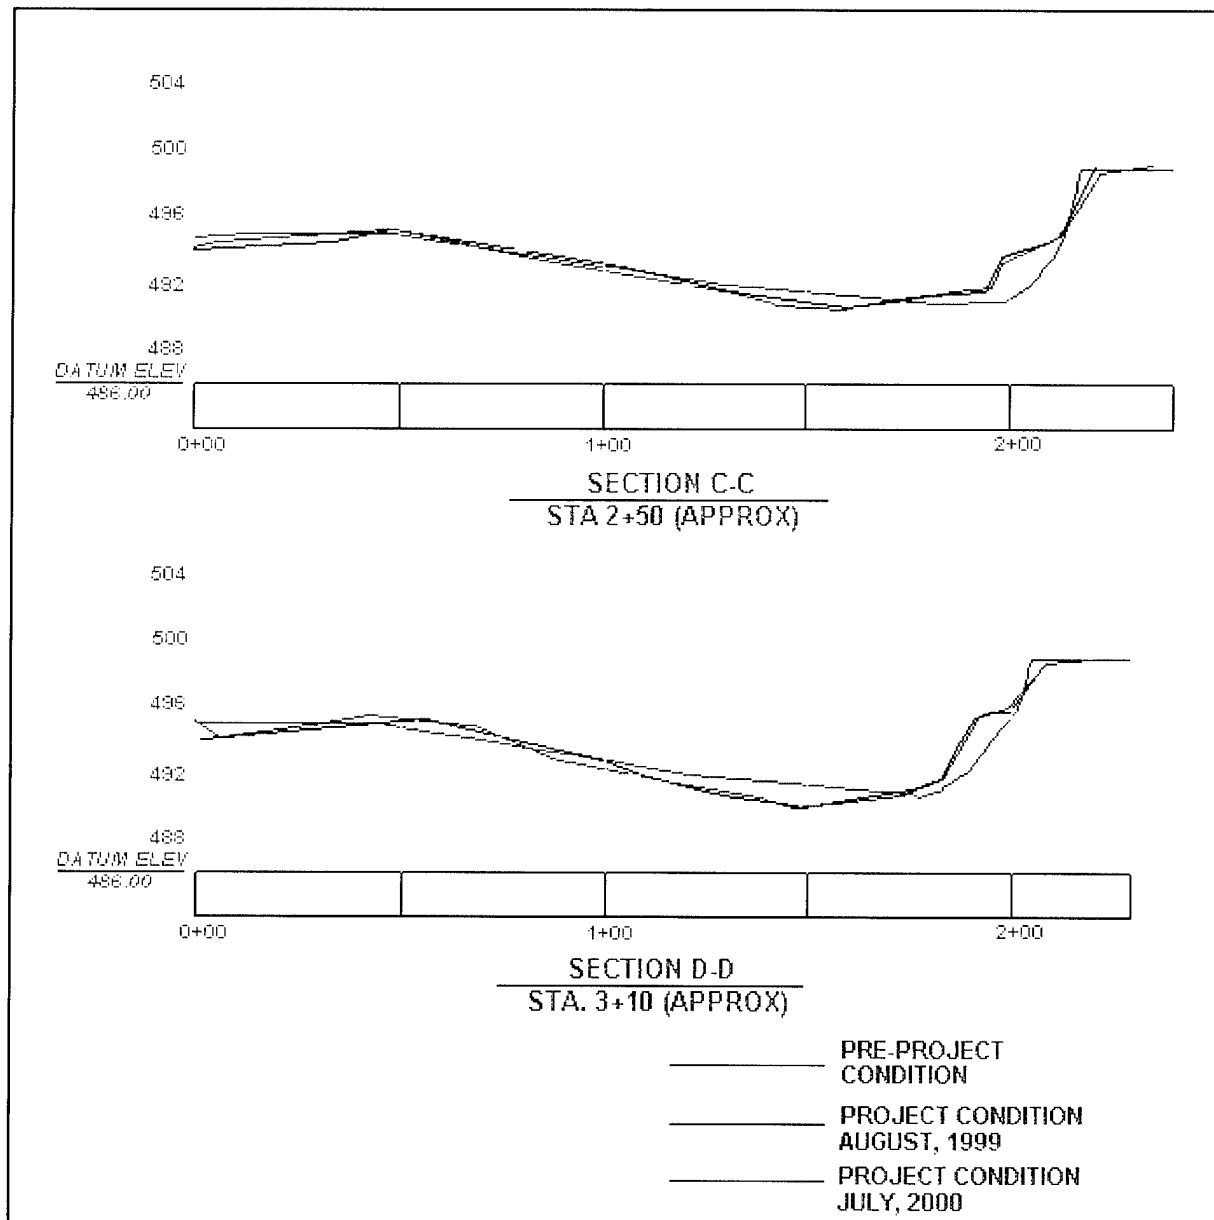
Figure A-2. Cross sections C-C and D-D as though looking upstream. Again, note how thalweg has shifted to the left and sediment has accumulated on the right bank

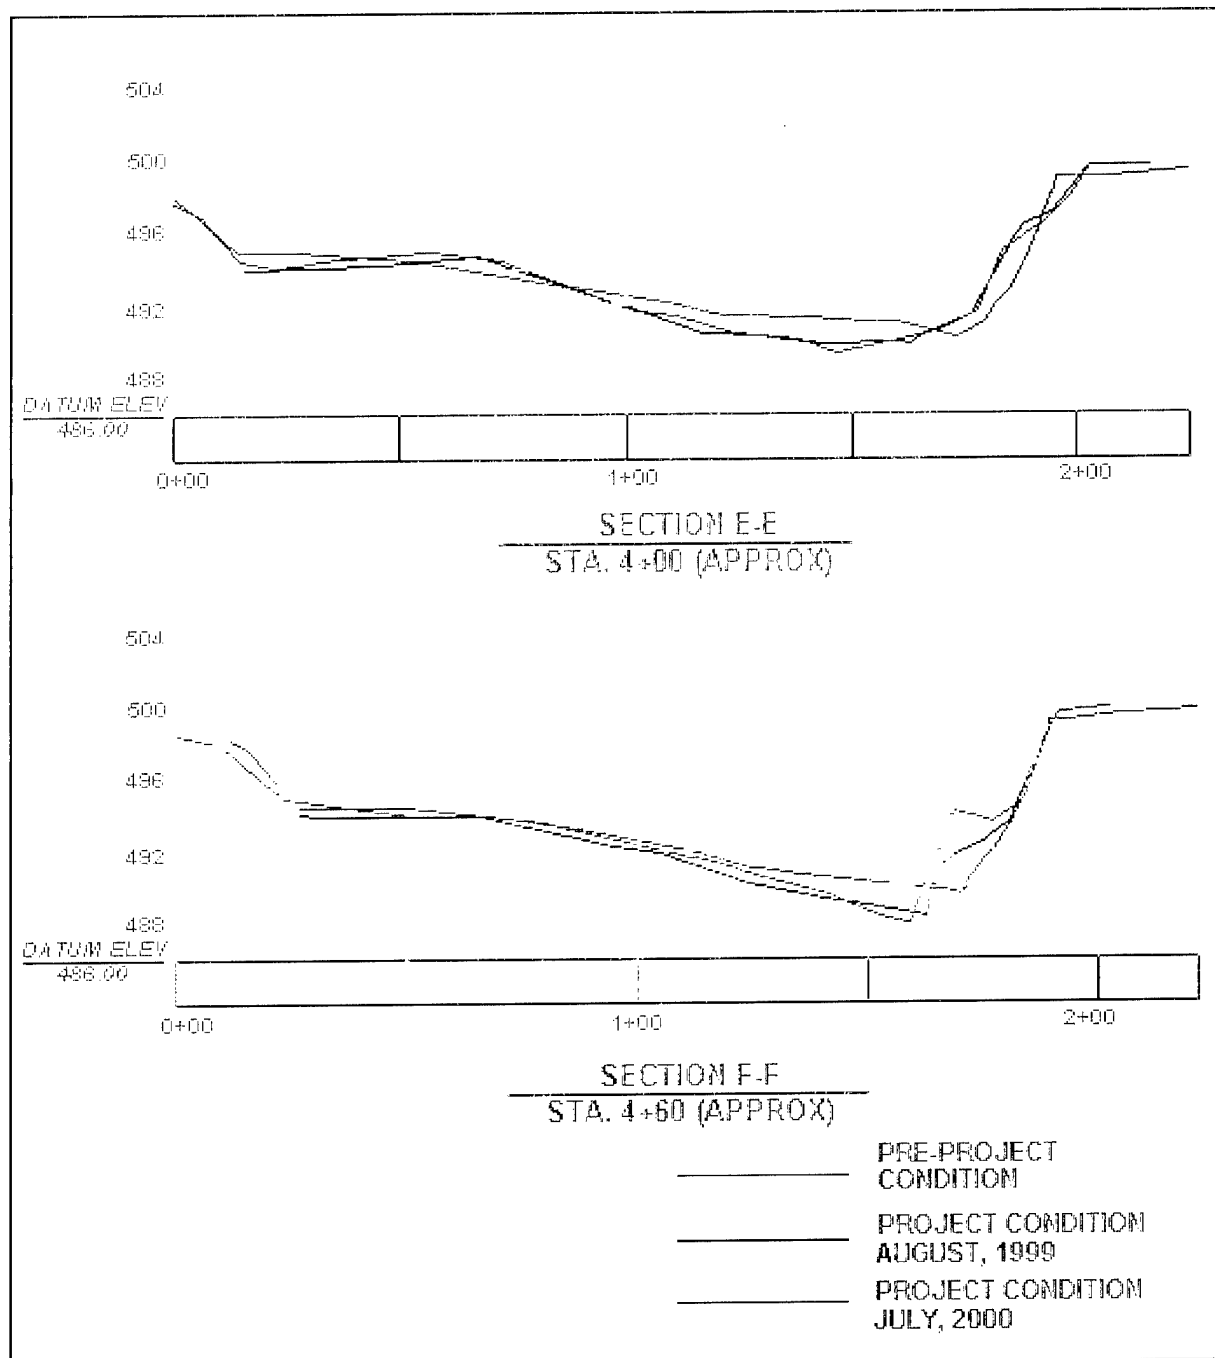
Figure A-3. Cross sections E-E and F-F as though looking upstream. Again, thalweg has shifted to the left
